Home Inspection Report

123 Main Street, Yourtown NJ

George Blair- Blair Inspection Services LLC

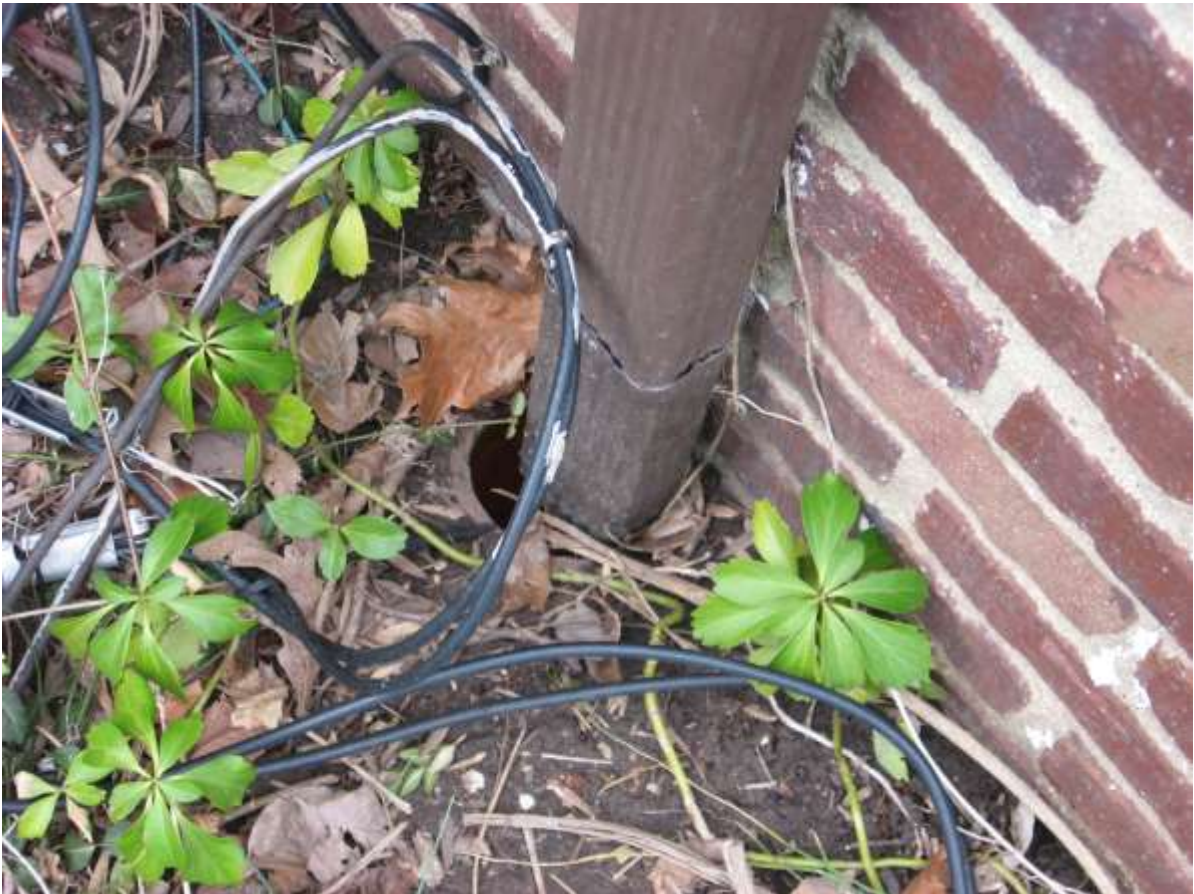
There are gutters and leaders comprised of aluminum hung by brackets on the facade and the side of the house. Most downspouts drain underground and to underground wells or the city street. There was one area on the left side of the house where the gutter did not extend far enough into the ground and this should be corrected to prevent blockage.

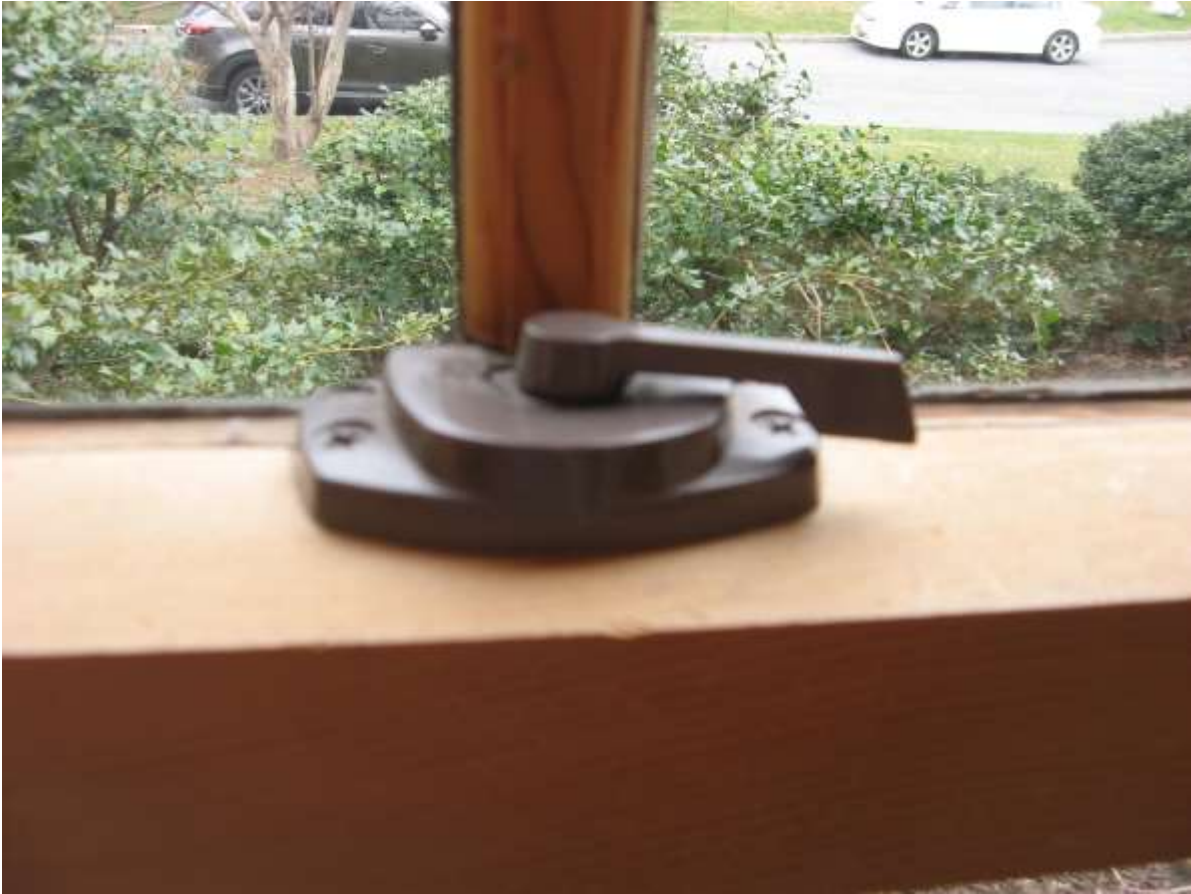
In the family room addition, all windows were updated with double hung Anderson type windows. They worked adequately. There was one window with a broken latch that needs to be repaired. See picture below.

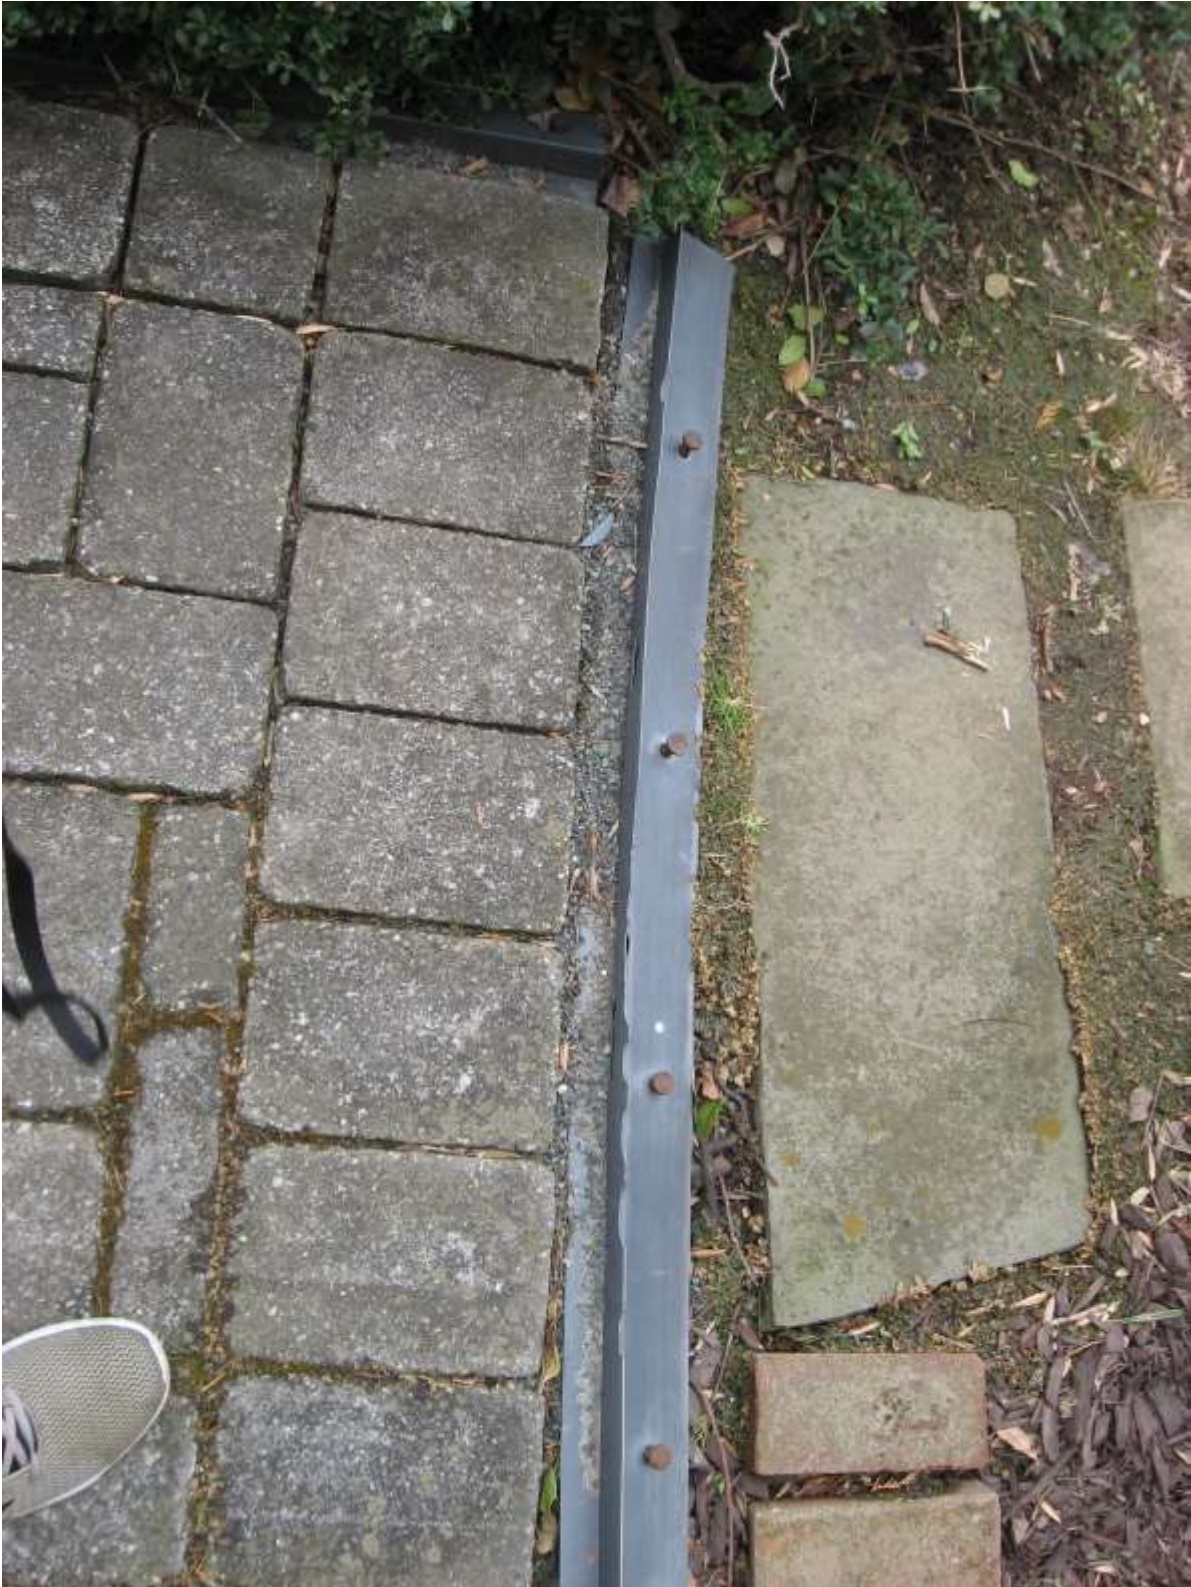
The front walkway to the house is interlocking masonry bricks and is in serviceable condition. There was one area as seen in the picture below where the plastic edging material was improperly installed and the fasteners were sticking up, which is a tripping hazard. In addition, the edging material was poorly installed along the leading edge closest to the street. This should be corrected as well. See picture below.

The plastic edging material under the front walkway needs to be repaired, as it is a tripping hazard. There is also a crack in the front patio wall that needs attention. A licensed contractor should be consulted for repairs

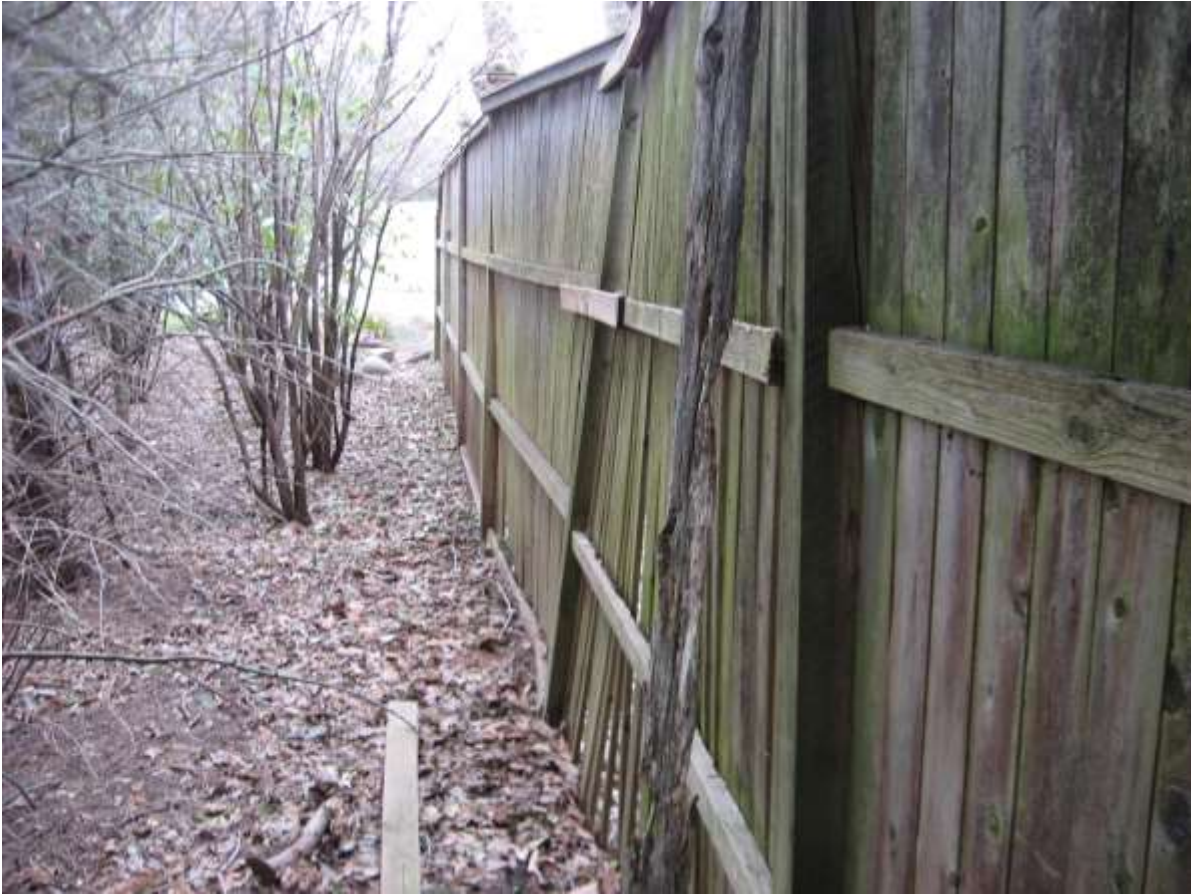
The backyard fence has failed in numerous places. It is recommended to have a licensed fencing company consulted for repairs and recommendations. In addition, the gate to the right of the garage has failed.

The wood fence at the back of the property needs repairs and replacement of numerous sections. There appears to be no buried footing for any of the posts and there is extensive wood to ground contact. All observed posts were loose. There is rot in many places and “home made” attempts to keep fence standing.

The fence sits on an interlocking wall that in places shows signs of movement over the years. **It is recommended to consult a fencing company for repair and replacement recommendations.**

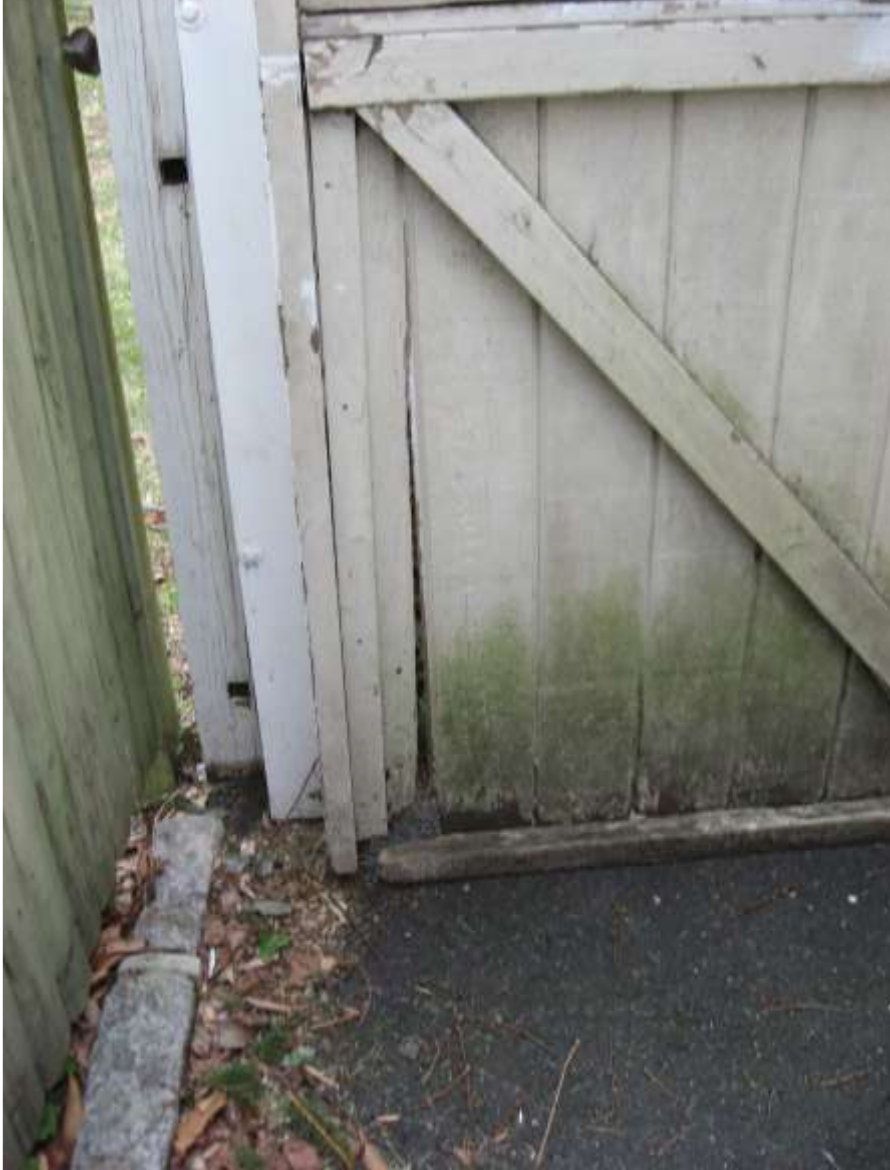
The detached 2 car garage visible walls and ceiling are in adequate condition. The visible area of the floor is in adequate condition and the automatic garage doors operate smoothly. The garage doors have been updated with an opener, with working door sensors at the bottom. The roof has been updated with a 30-year architectural style shingle roof with a ridge vent. There was some carpenter ant activity noted in the soffits. In addition, **there was a missing cover plate on an outlet in the garage.** The fence door to the right of the garage was rotted and needs replacement, see picture below.

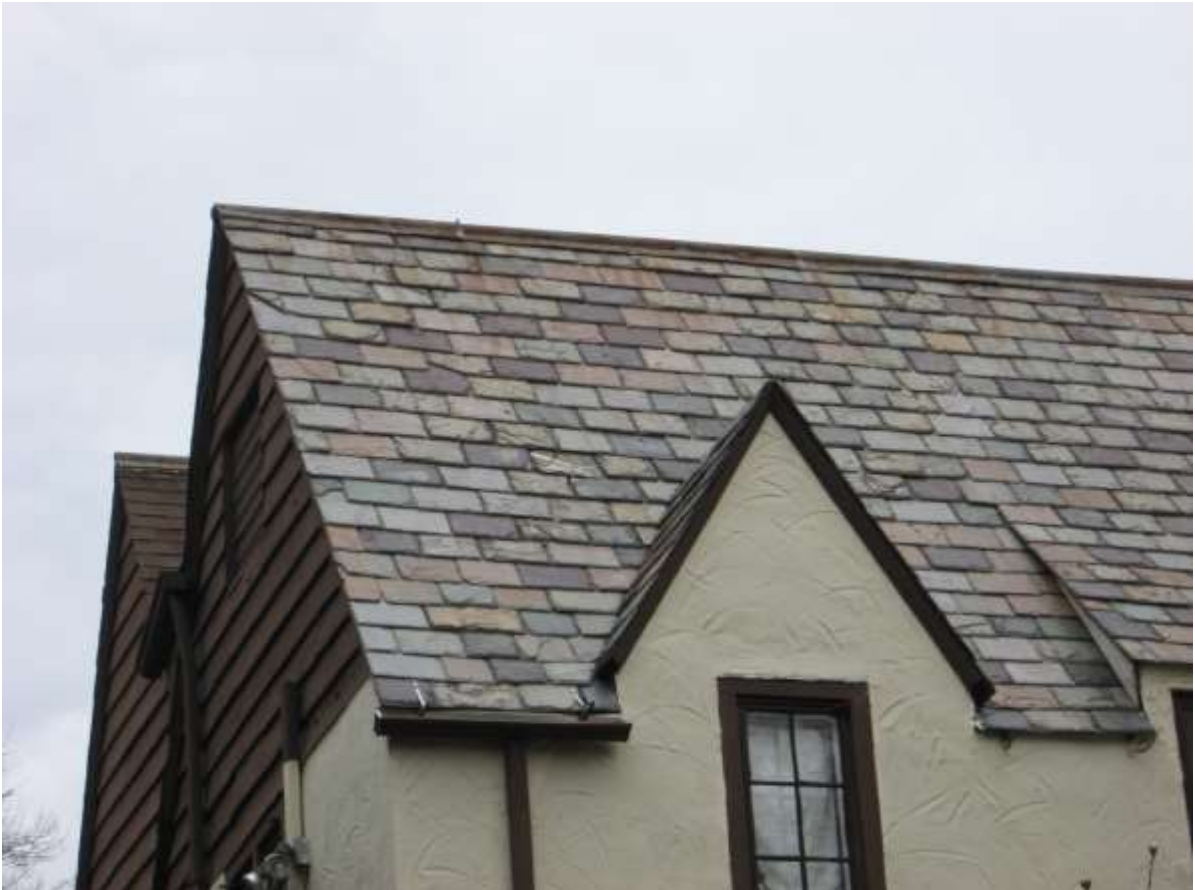
There are a few areas where slates have chipped. In addition, the roof rafters are much longer than the observed ridge beam as observed from the attic. A licensed slate roofer should be consulted for repair recommendations.

The house roof is comprised of original and some replacement slates over the years. The exact age is not determined however it is felt to original to the house (circa 1936) and accordingly 83 years old. An exact estimate of the usable years remaining for the shingles is difficult to give. **There are a few areas where slates have chipped on the east side of the roof. A licensed slate roofer should be consulted for recommendations. See picture below.**

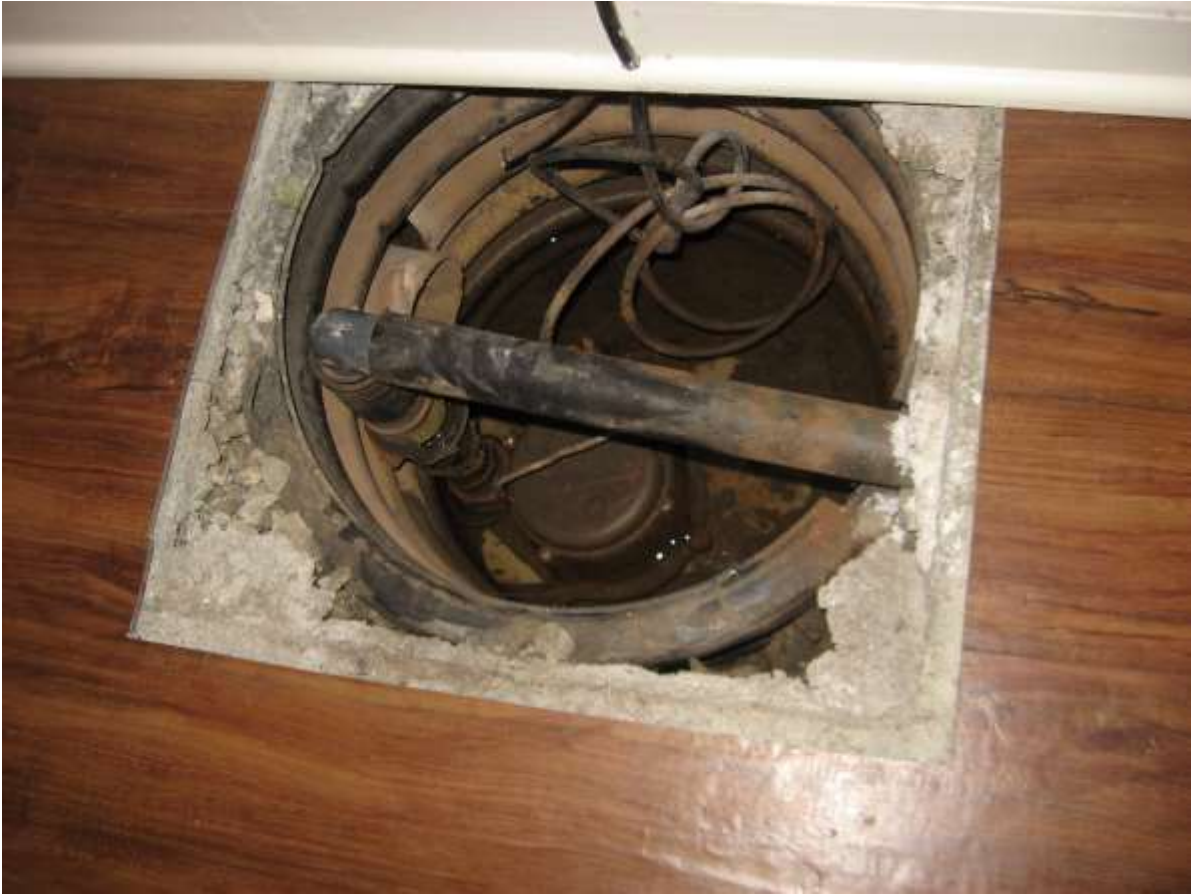
An extension cord to an outlet attached one sump pump, while the other unit was plugged into a wall outlet and drilled through the baseboard and floor. **Sump pumps usually need their own dedicated outlet circuit and in some jurisdictions require that a gfi be installed. Please check with town and correct as necessary.**

The sump pumps need to be tested prior to closing, since they were sealed during the inspection. In addition check with town regarding dedicated electrical outlets for sump pumps and correct as necessary.

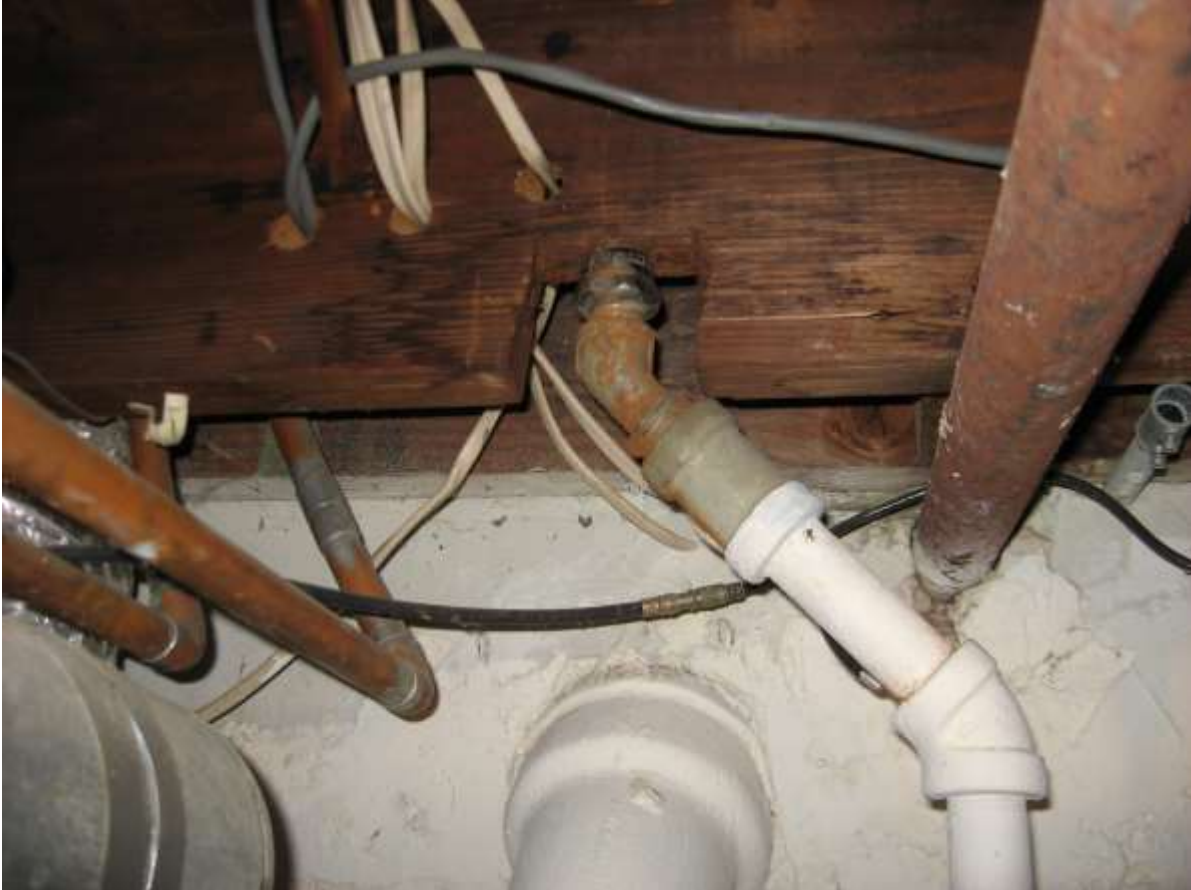
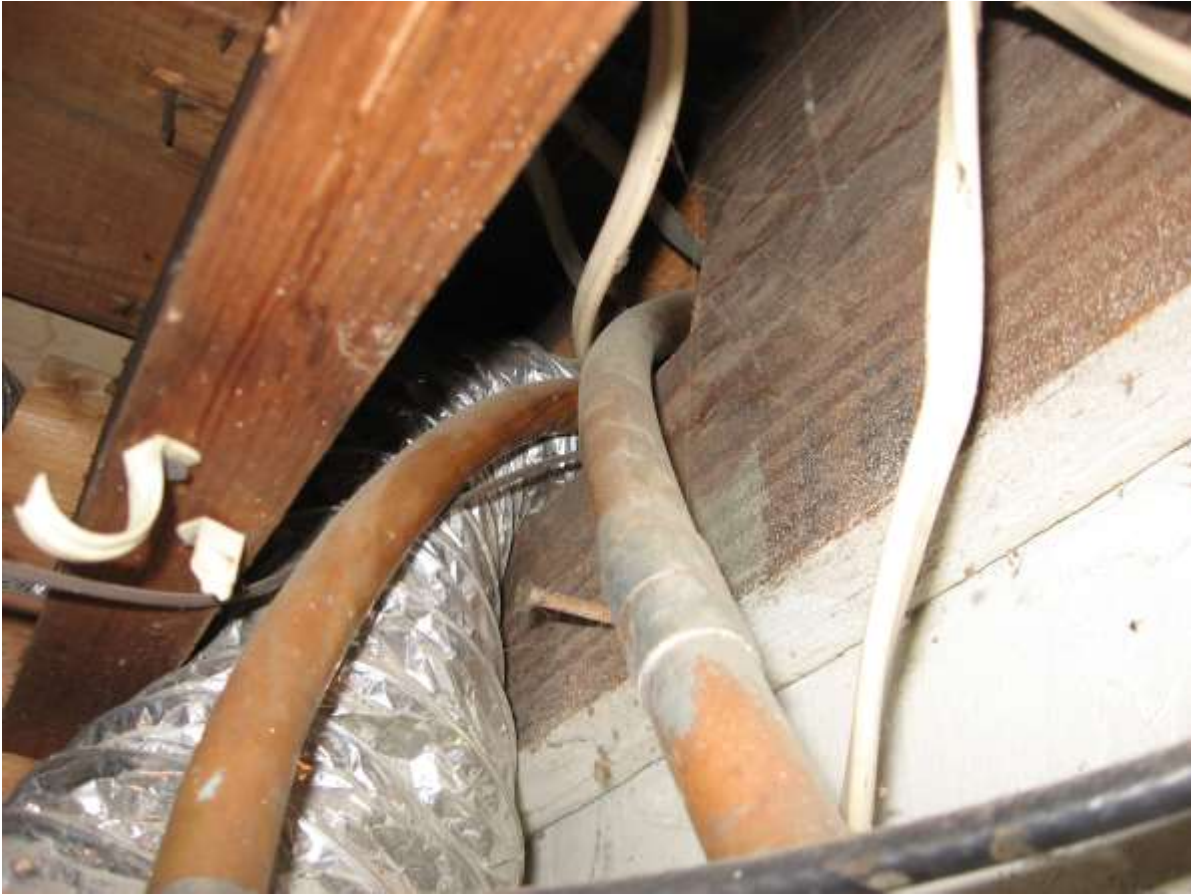
There are two notches in the unfinished basement of possible concern. The first beam has been notched at the

bottom to accommodate a water valve for the heating system and the second to push plumbing up into the house. Notches are not recommended to exceed $\frac{1}{4}$ of the total depth of the beam. See pictures below and consult a licensed contractor for solutions.

There are two notched beams in the basement that are of possible concern. The first beam has been notched at the bottom to accommodate a water valve for the heating system and the second beam on top of the sill has been cut to accommodate plumbing. Notches are not supposed to exceed ¼ of the total depth of the beam. Consult a licensed contractor for solutions

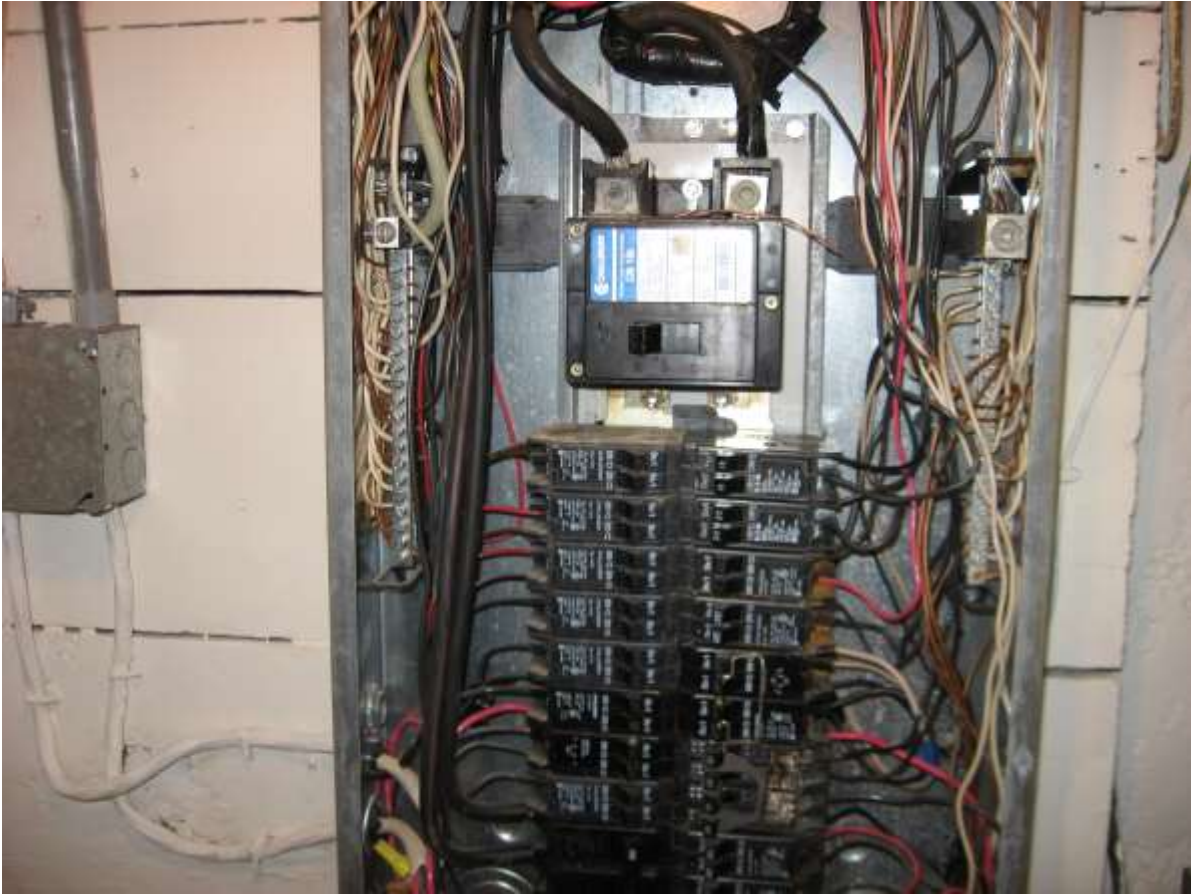
There is evidence of past/current water intrusion into the main electrical panel. The duct seal on the outside electrical panel is dried and brittle. There is an old outlet in the porch that is dead along with an open ground in the left front and master bedrooms. There is a missing cover plate in the garage. These problems need to be addressed by a licensed electrician.

The main service disconnect located in the main panel located in the basement has an approximate capacity of 150 and a 100 amperes subpanel each at 240/120 volts. The cover was removed. There are spares in both. **The main panel had evidence of past/current water damage in it.** There was efflorescence on one of the main disconnects. There were double taps and scorch/burn marks on the breakers. In addition the duct seal around the exterior meter should be replaced as it is becoming dried and brittle. **These concerns need to be addressed by a licensed electrician.**

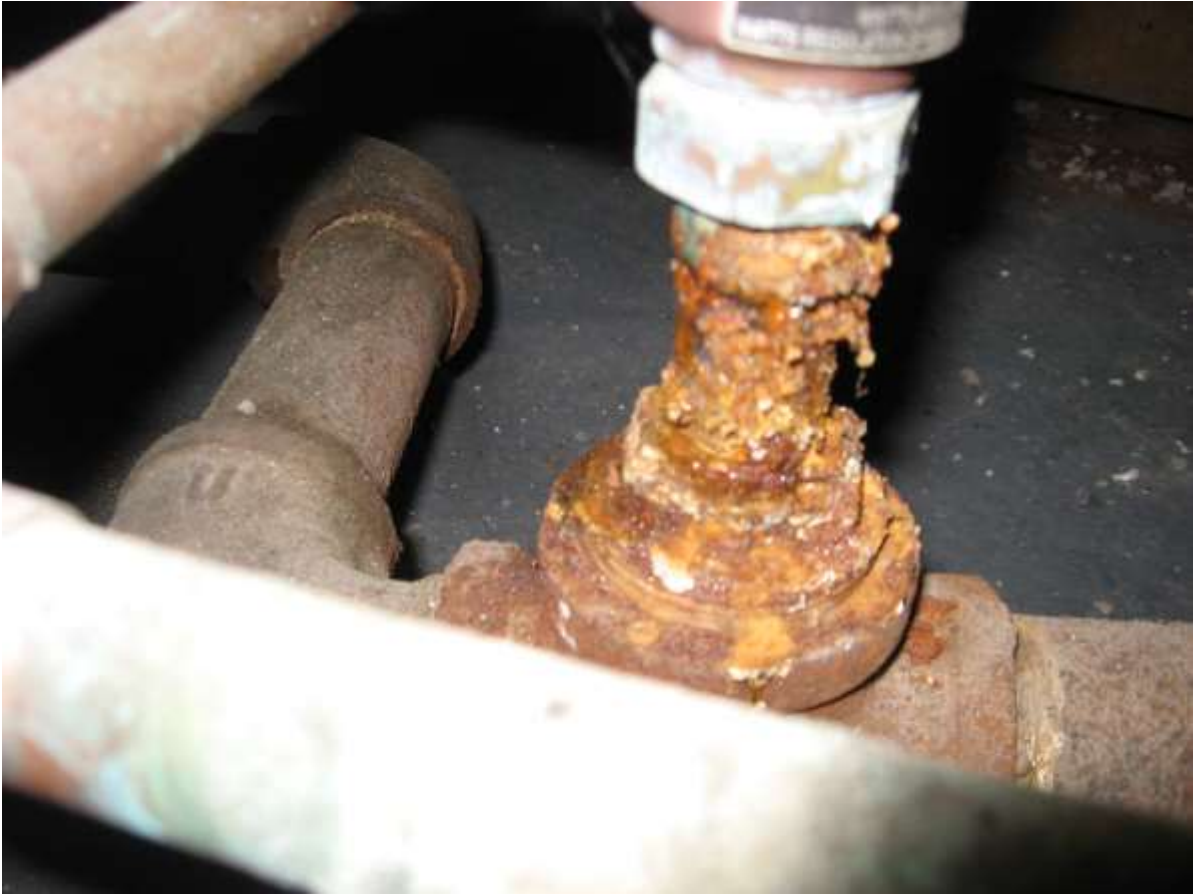
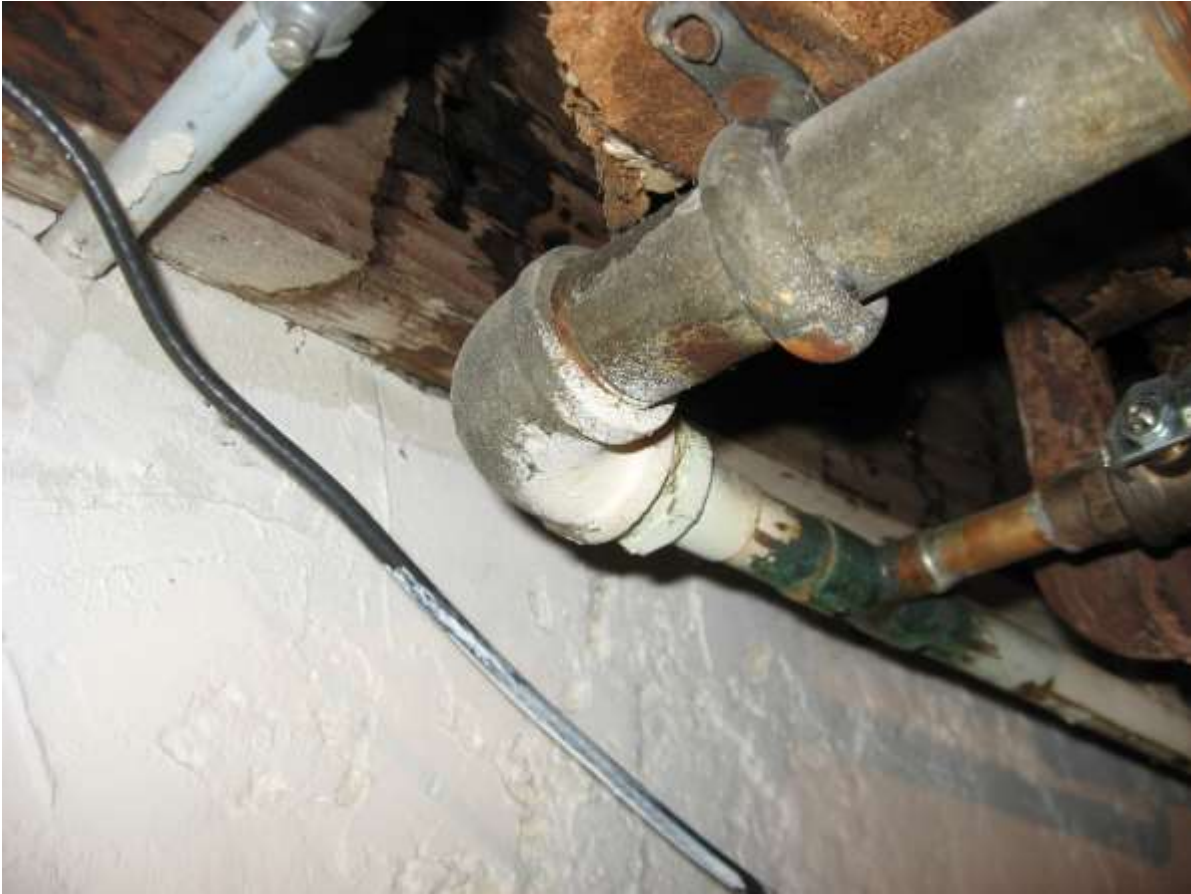
There is evidence of brass plumbing in the house. There are some original brass water pipes possibly still active in various locations in the walls. While no leaks have been discovered, these pipe have reached their life expectancy and will require updating at any time. This will require opening wall and ceilings. Valves and connections between two dissimilar pipes are most prone to leaks evident by efflorescence. [L
SEP] Fittings, valves, Tee's and elbows may corrode and leak over time due to many circumstances that will need repairs. **See pictures below**

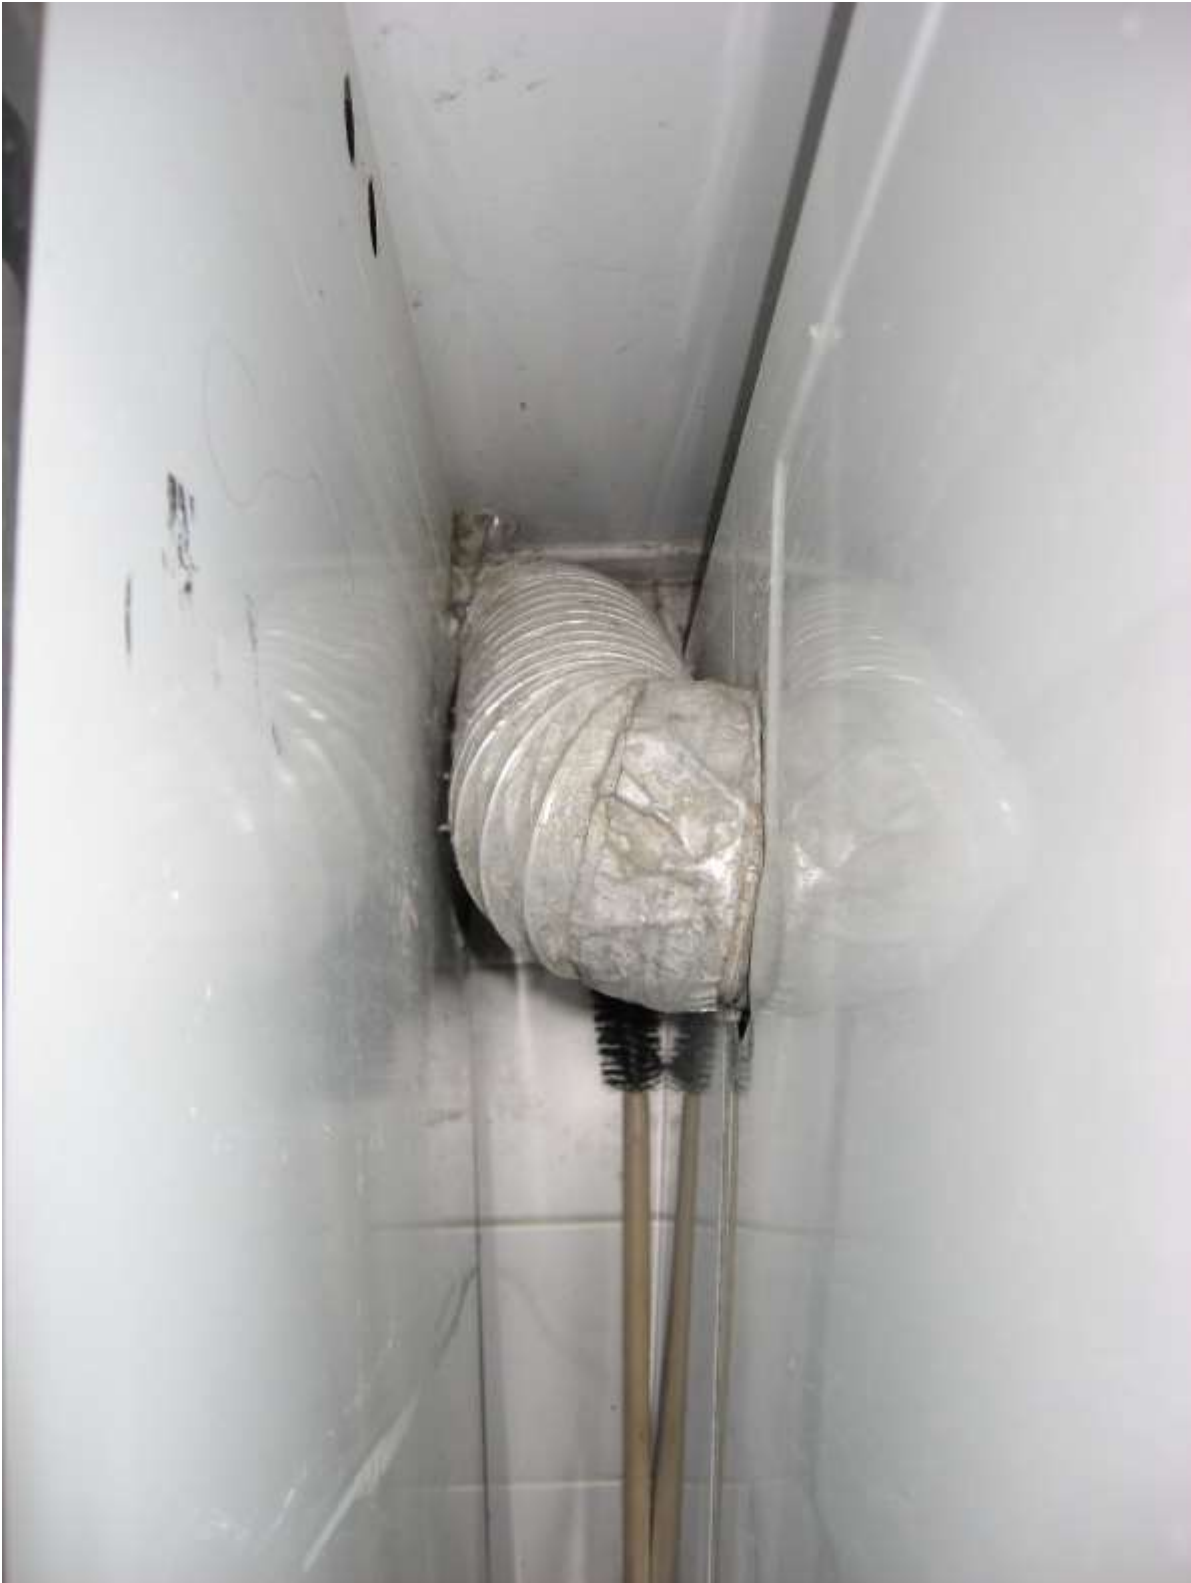
The foil dryer vent is a fire hazard and should be replaced with a rigid type.
